Name Of Dam: UPPER NORTH RIVER NO. 76 (ELKHORN LAKE)

Location: AUGUSTA COUNTY, VIRGINIA

Inventory Number: VA. NO. 01506

PHASE I INSPECTION REPORT

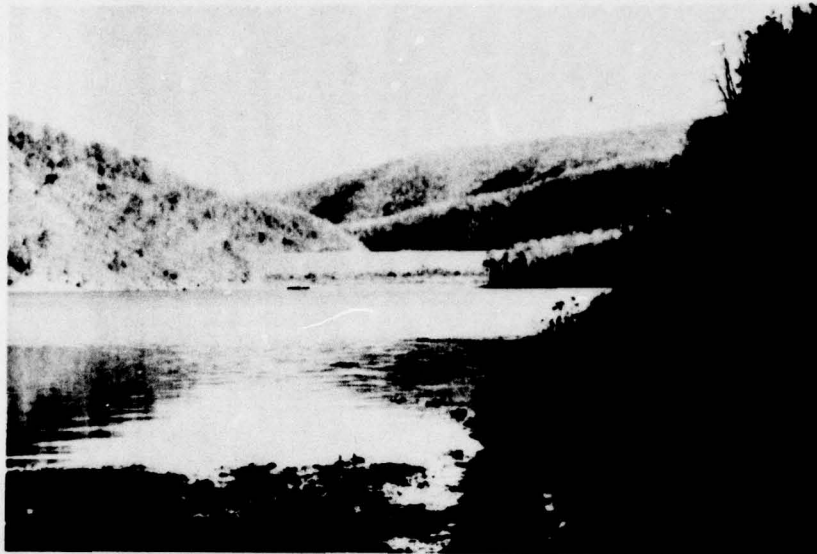
OVERALL VIEW - ELKHORN LAKE
(View from the West)

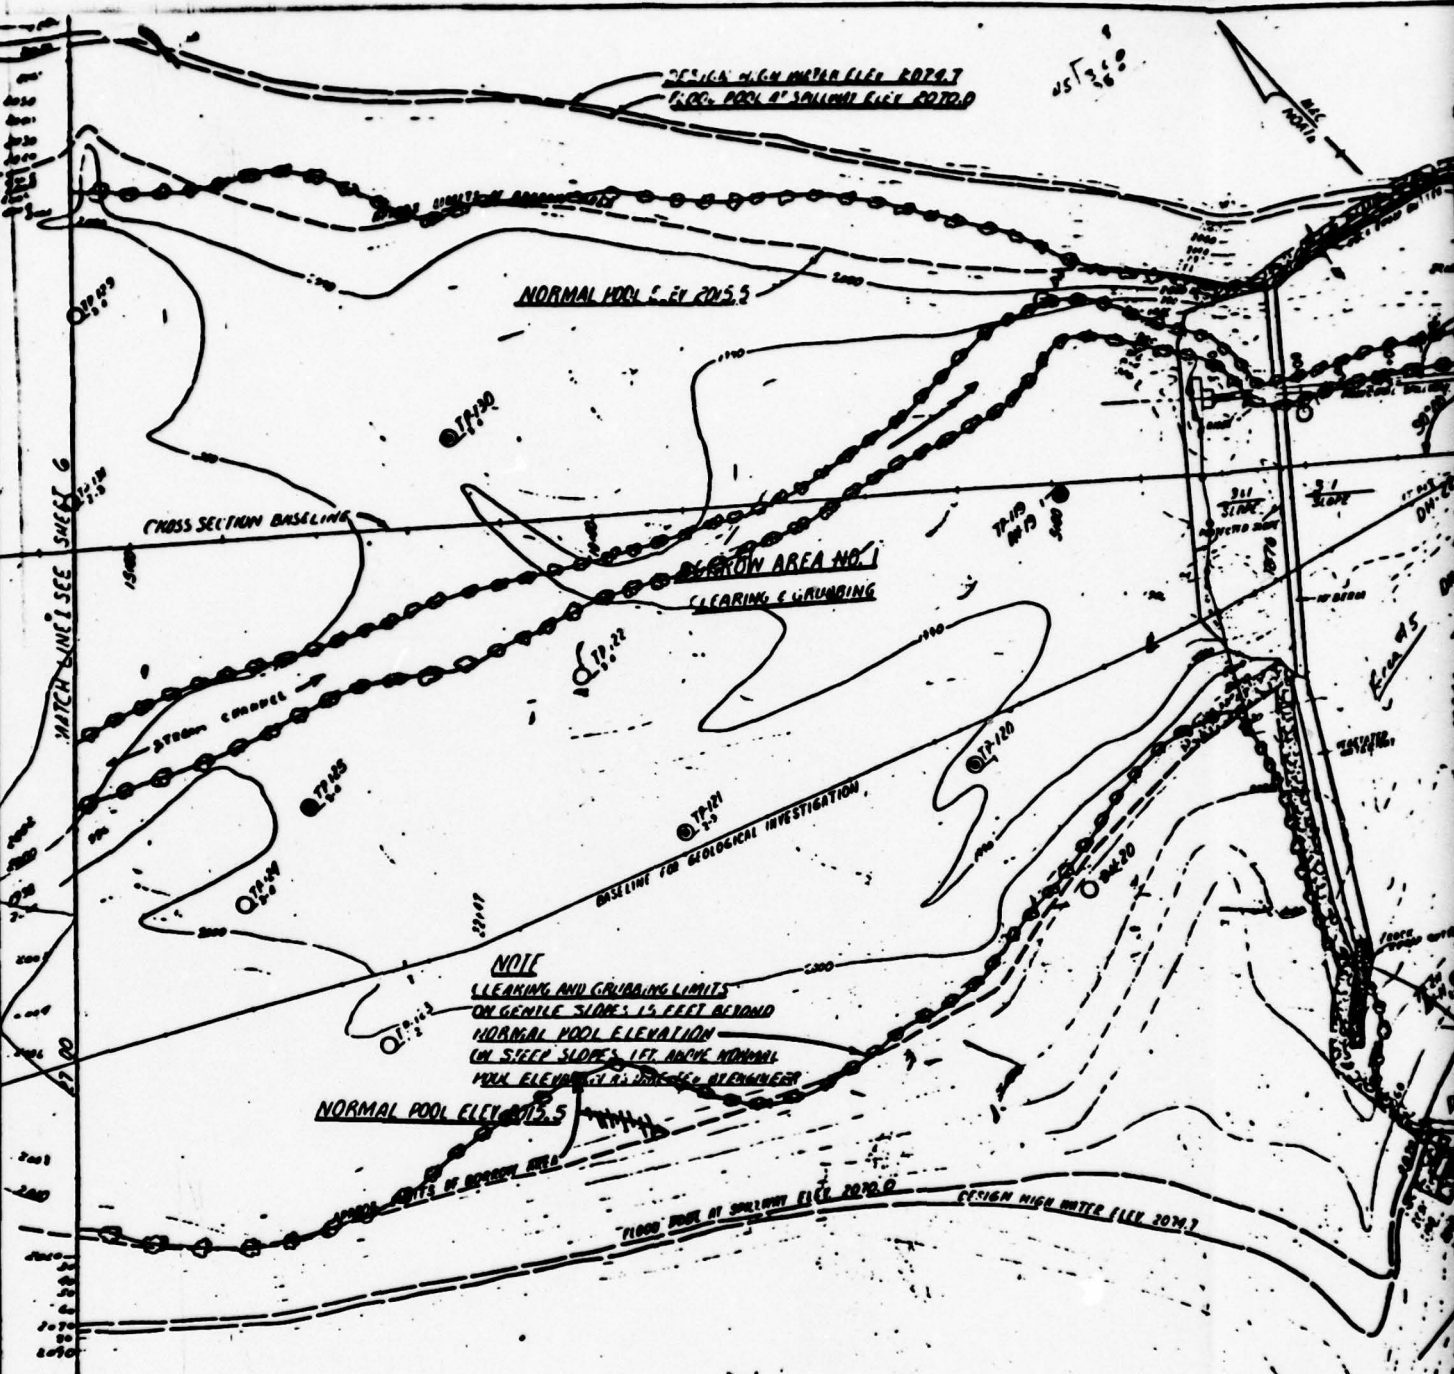
AS BUILT SHEET 2

Wet spots observed along the drainage berm on the downstream slope are probably the result of recent ponding from precipitation, and runoff along low areas in the berm. The general location of these wet spots is illustrated on Sheet 2 in Appendix I. These wet spots occur at El 2026+, while normal pool is at El 2015.5, therefore, they are not the result of seepage. The downstream berm slopes toward both abutments to the riprap gutters, thus providing an adequate drainage system for collecting runoff. If increased ponding continues in the future, local grading may be required to allow better drainage of this berm.

The area of damp soil illustrated on Sheet 2, Appendix I, is believed to occur because of seepage of the water ponded above in the drainage berm. This condition is not believed to be related to seepage through the dam.

⊙ WET AREAS ON DRAINAGE BERM

1.7 Seepage: One damp spot was noted about 20 ft right of the left abutment and about 50 ft downstream of the midslope drainage berm. We believe this wet area at about EL 2005 is the result of surface water seeping from the drainage berm above.

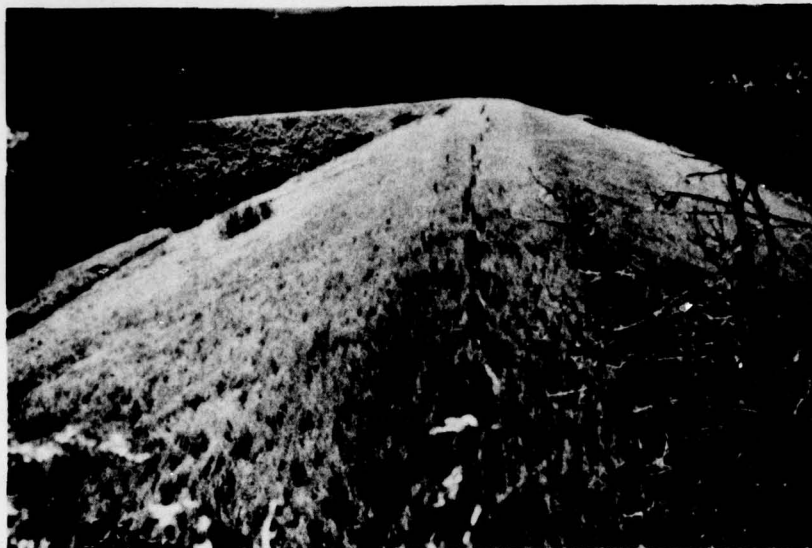
TOP OF EARTHEN BERM
VIEW FROM NORTHEAST
Photo #1

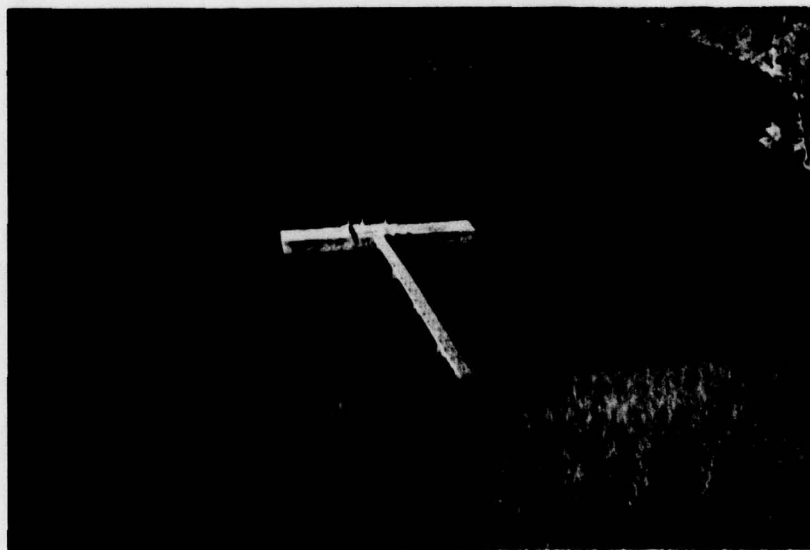
PRINCIPAL SPILLWAY STRUCTURE
(GOOD CONDITION)
Photo #2

4.1 Intake Structure: The structure was in good condition. Gates were well greased, however, the lower gate is inoperable. Catwalk was in good condition. Concrete on the structure visually was in good condition.

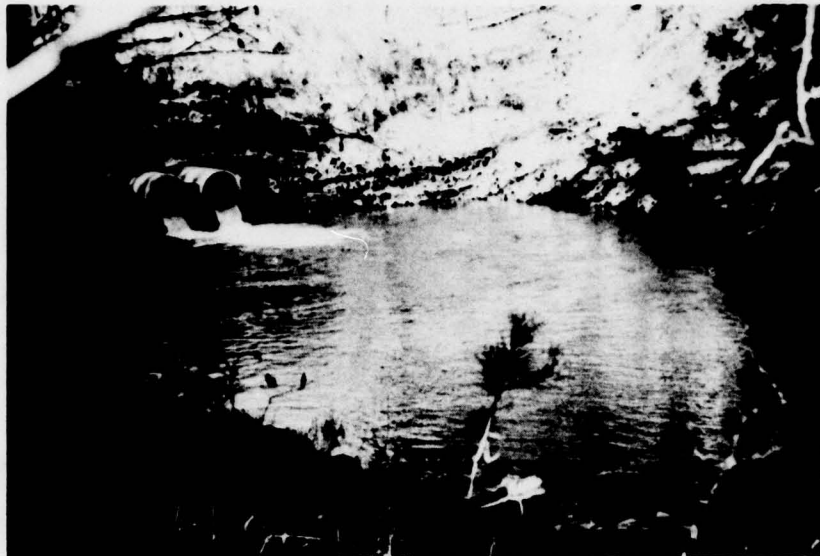
STILLING BASIN AND OUTLET PIPE
(NOTE RIP RAP AND STILL WATER SURFACE)
Photo #3

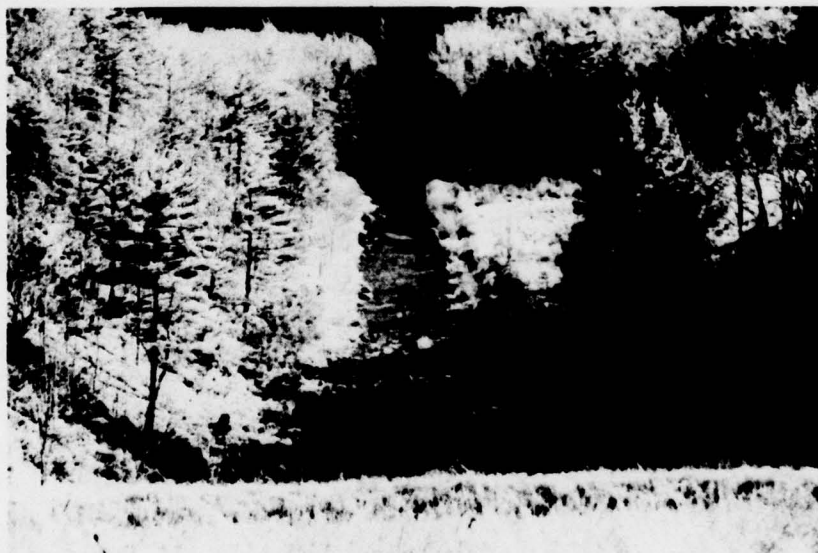
DOWNSTREAM CHANNEL
(GOOD CONDITION)
Photo #4

3.1 Condition: Good. Channel has rock bottom.
